CONTINUING ELIGIBILITY INSPECTION (CEI) REPORT
FOR HURRICANE & SHORE PROTECTION PROJECTS
Honolulu Engineer District
CEPOH-EC-T

1. Project Name: Poloa Shore Protection Project

2. Date of Inspection: March 15, 2005

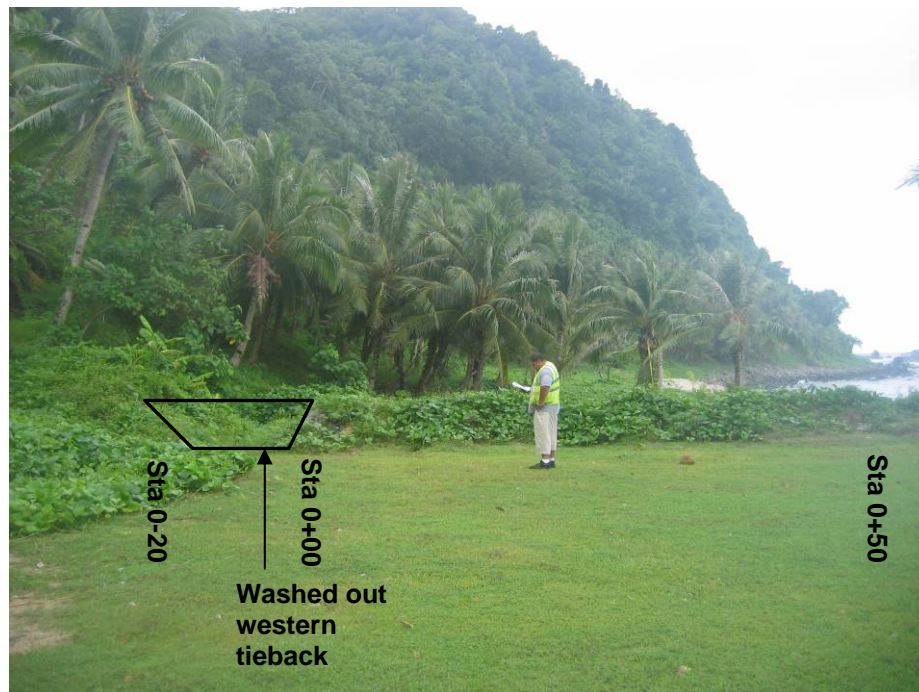
a. Sta 0-20 to 0+50, Remove vegetation at washed out western tieback and on structure with herbicide.

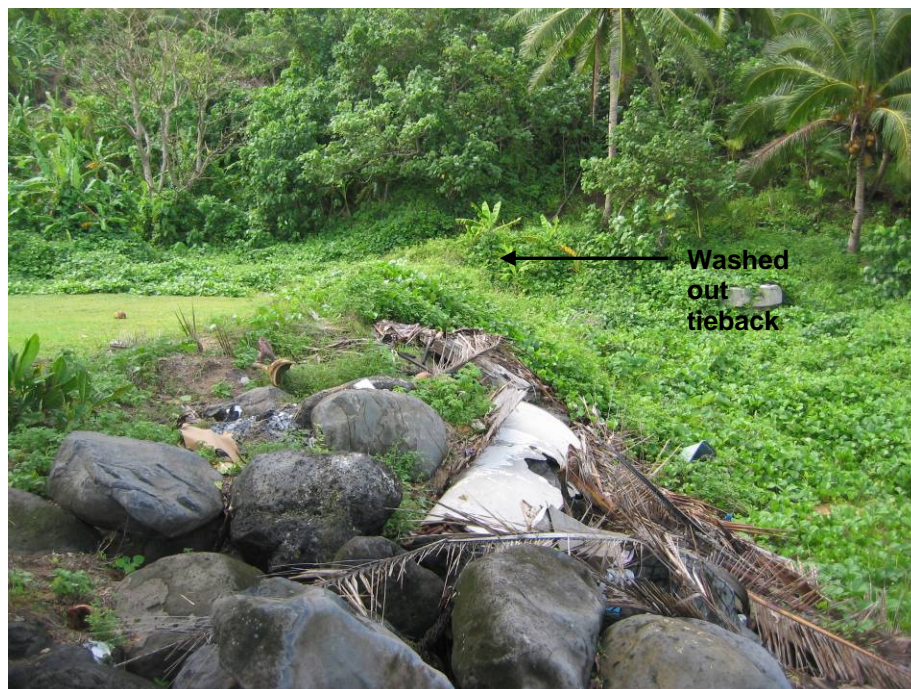
b. Sta. 0-20 to 0+65, Remove vegetation and debris from structure.

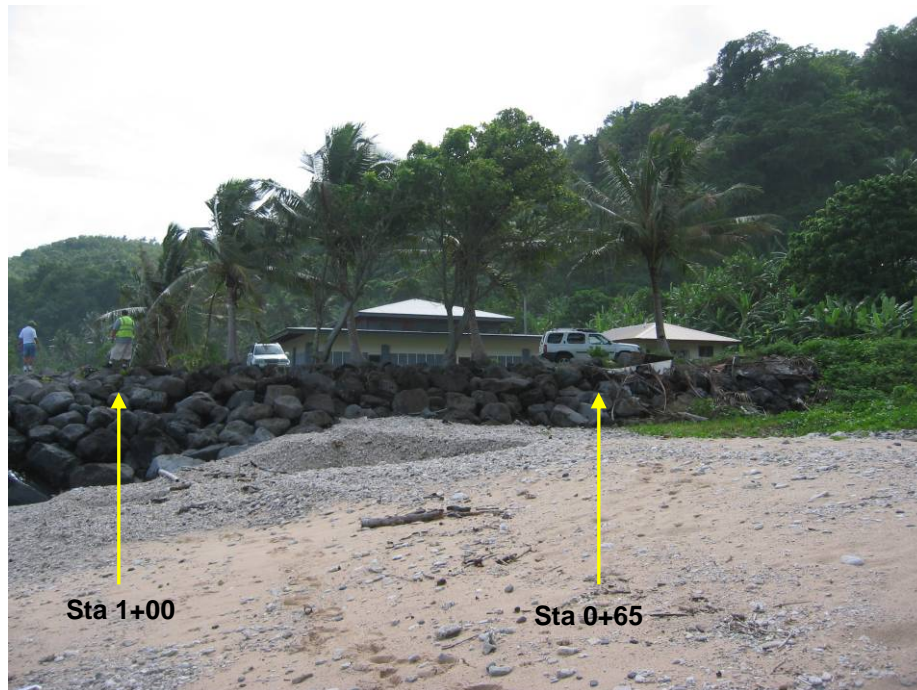
c. Sta. 0+65 to 1+00, Note poor contact and dislodged armor stones at toe along this reach, to be reset during repair.

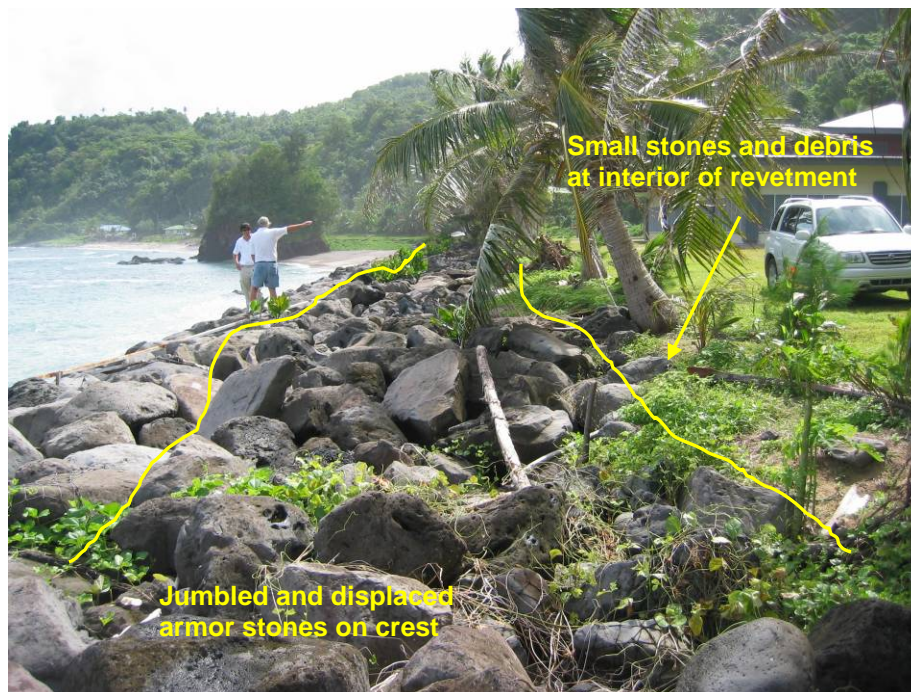
d. Sta. 1+00, facing shore parallel. Much of the crest is at lowered elevation and stones are jumbled or displaced. Remove juvenile trees, vines and debris along revetment crest.

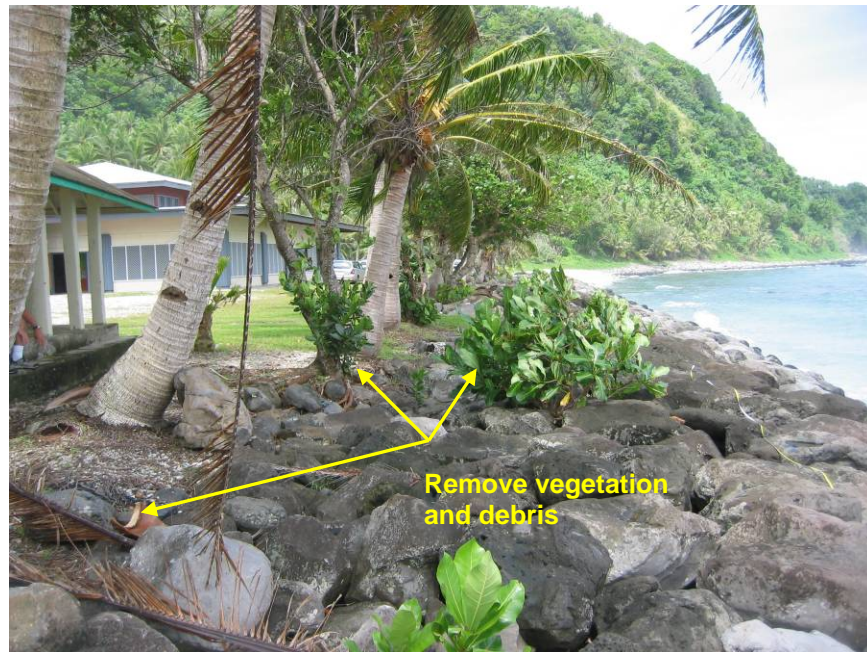
e. Sta. 4+45, Overview from eastern side of revetment. Crest stones primarily intact at this end. Remove vegetation and debris.

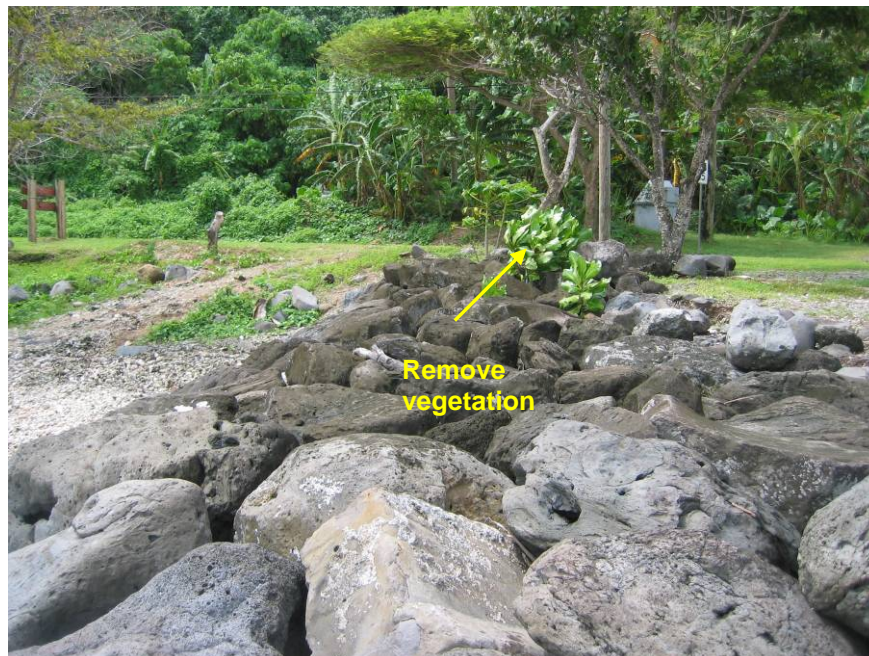
f. Sta. 4+45, facing landward. Crest is in fair condition, some stones to be reset to improve interlocking as part of repair. Remove vegetation.

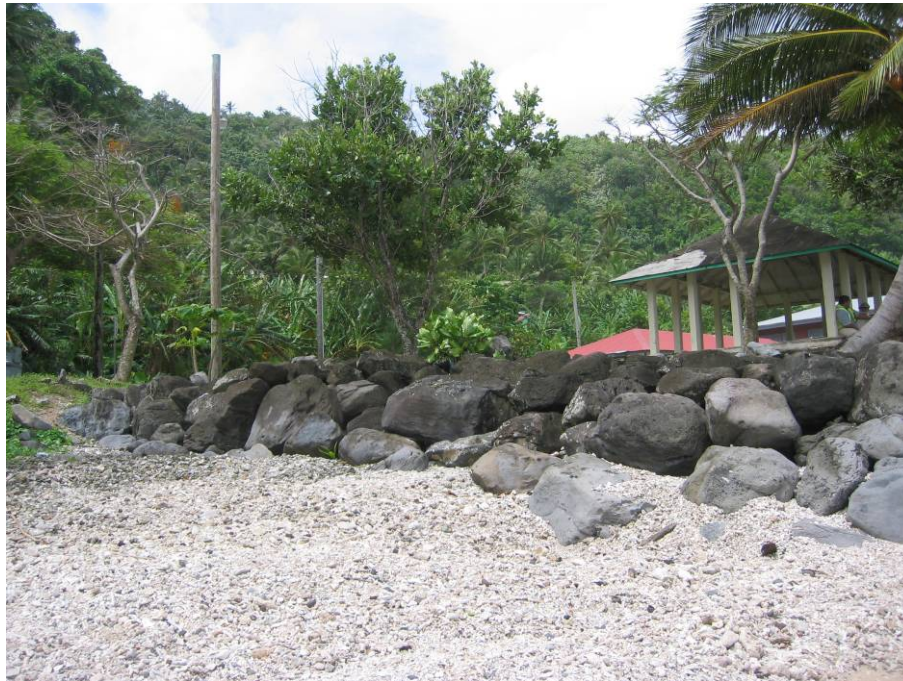
g. Sta. 4+45 to 4+90, Poorly interlocking and dislodged stones on sideslope to be reset during repair.

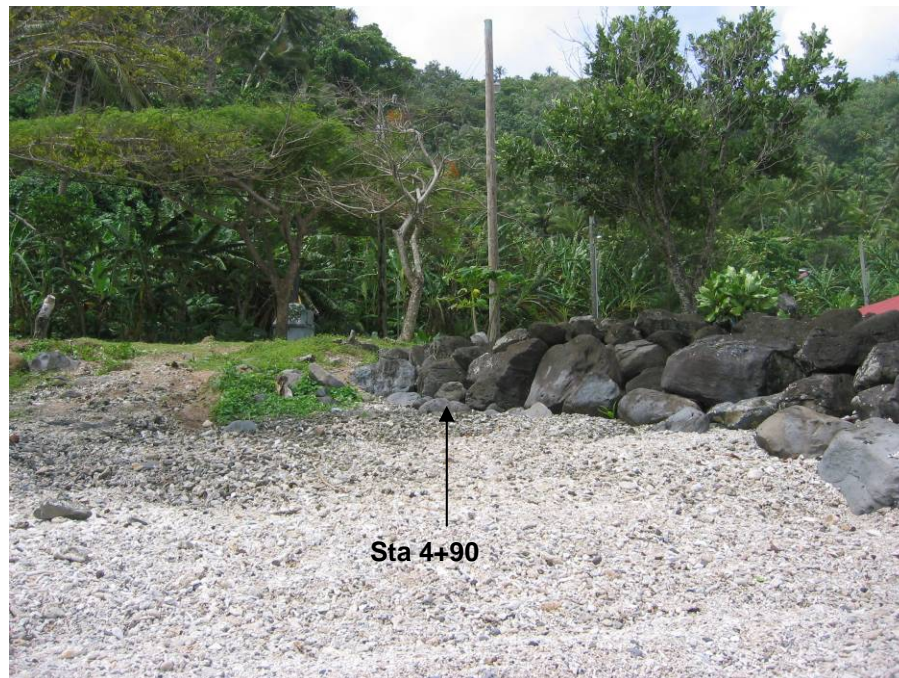
g. Sta. 4+90, Eastern tieback in fair condition. No repairs to this area included in upcoming repair.
